NASA TN D-5050

MECHANICAL BEHAVIOR OF BORON-EPOXY AND GLASS-EPOXY FILAMENT-WOUND CYLINDERS UNDER VARIOUS LOADS

by Harvey W. Herring, Robert M. Baucom, and Richard A. Pride

Langley Research Center

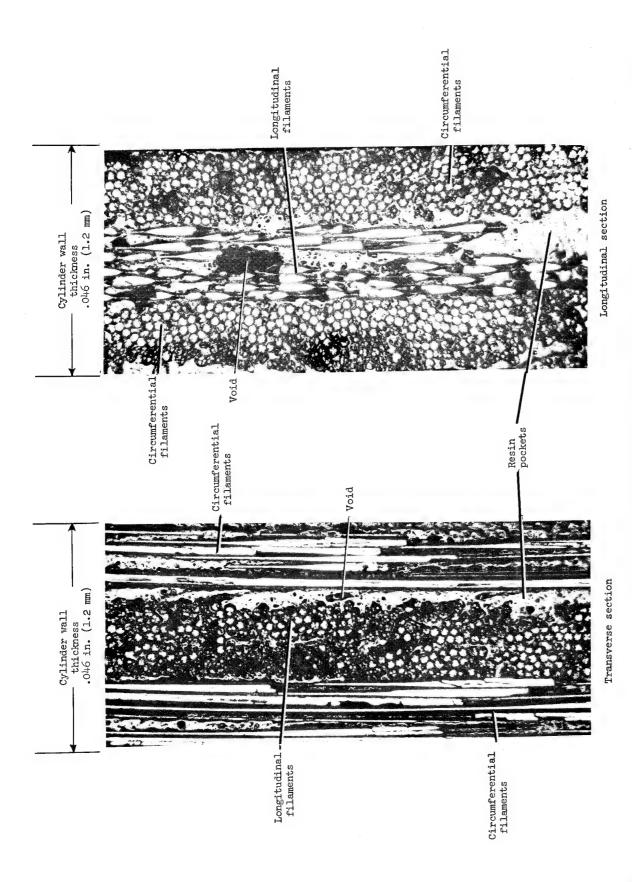
Boron-epoxy cylinder sections. Both transverse and longitudinal sections cut from the wall of an orthotropic boron-epoxy cylinder are shown in figure 17. The entire cylinder wall thickness is shown, and the wrapping sequence is circumferential — longitudinal — circumferential. The black areas around most of the filaments do not necessarily represent voids in the specimens. The boron filaments are so hard that during polishing the resin surrounding each filament is worn away to a depth which is out of focus at the magnification of the figure; thus, black areas around most of the filaments are shown. If the resin continues to be worn away, however, the unsupported filament end may break off. This occurrence may be responsible for some of the gross voids indicated in figure 17.

Figure 17.- Typical sections from an orthotropic boron-epoxy cylinder wall.

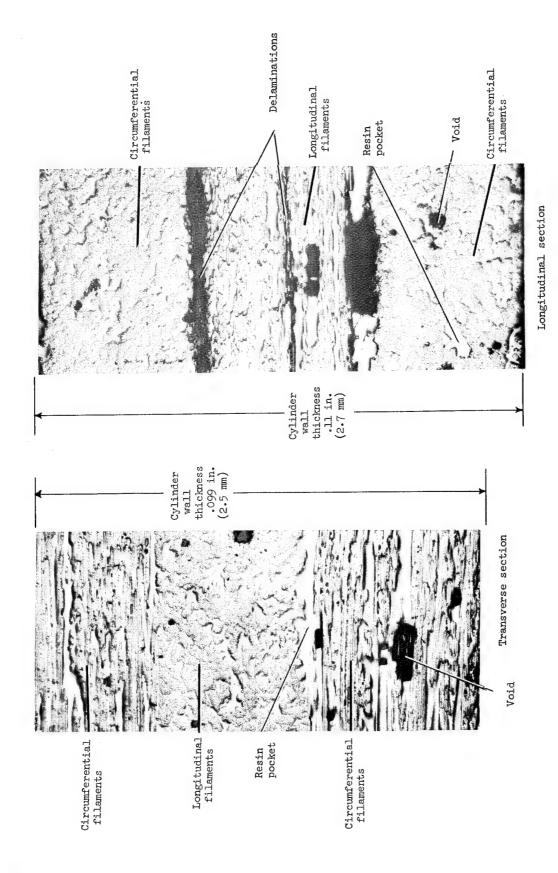
L-68-10,073

Glass-epoxy cylinder sections. In figure 18 typical tranverse and longitudinal sections from an orthotropic glass-epoxy cylinder are shown. Again the entire cylinder wall thickness is shown with circumferential wraps at the inner and outer surfaces and the longitudinal reinforcement in the center. Voids, filaments, and resin pockets are indicated on the figure. In the longitudinal section separations, or delaminations, occur between the layers and within the longitudinal layer. These delaminations cause the longitudinal section to be thicker than the transverse section. These specimens were taken from cylinders which had been loaded to failure, and the delaminations probably resulted from the applied load.

Figure 18.- Typical sections from an orthotropic glass-epoxy cylinder wall.

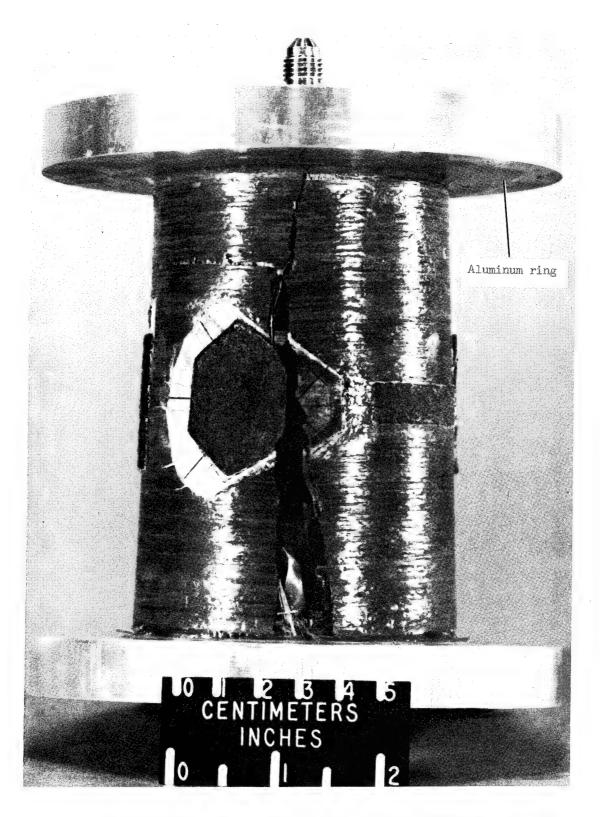
L-66-5700.1

Internal pressure failures.- The cylinders shown in figures 20 to 24 were failed by internal pressurization. Figures 20 and 21 are photographs of the two orthotropic boronepoxy cylinders, which were the only cylinders of the same type failed under identical loading conditions. Failure occurred suddenly with a sharply defined fracture nearly perpendicular to the circumferentially wrapped filaments. An isotropic boron-epoxy cylinder is shown in figure 22. For this cylinder, failure occurred along a line approximately parallel to one set of helically wrapped filaments breaking the filaments in the opposed helical layers and the circumferential layers. All the boron-epoxy cylinders subjected to internal pressurization failed suddenly whereas failure of the glass-epoxy cylinders, shown in figures 23 and 24, occurred more gradually. The orthotropic glass-epoxy cylinder in figure 23 failed by unraveling and bulging as the pressure was increased beyond a certain value. Failure of the isotropic glass-epoxy cylinder shown in figure 24

Figure 20.- Orthotropic boron-epoxy cylinder failed by internal pressurization.

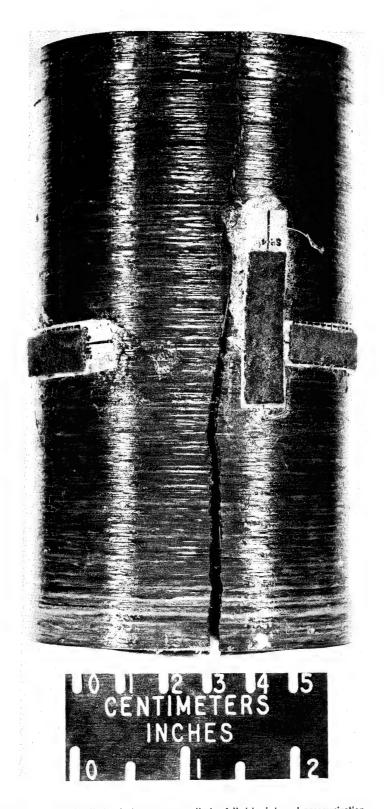
L-67-3214

Figure 21.- Second orthotropic boron-epoxy cylinder failed by internal pressurization.

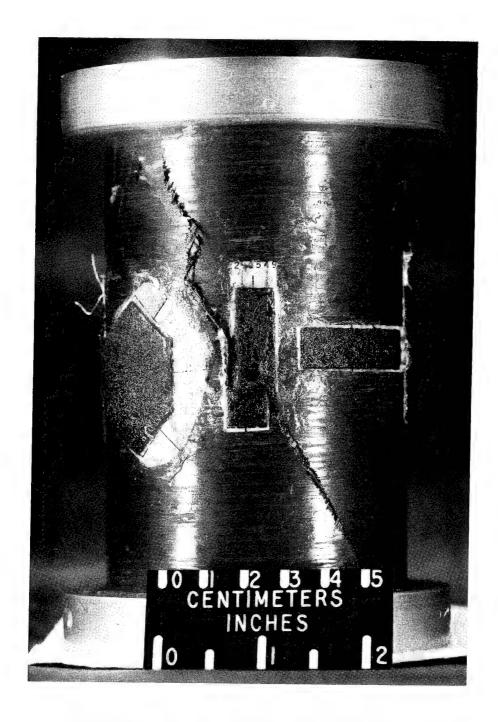
L-66-10070

Figure 22.- Isotropic boron-epoxy cylinder failed by internal pressurization.

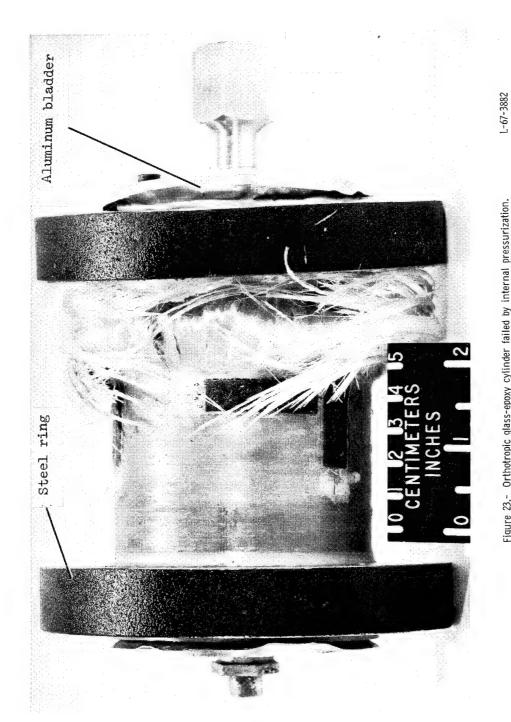
Figure 23.- Orthotropic glass-epoxy cylinder failed by internal pressurization.

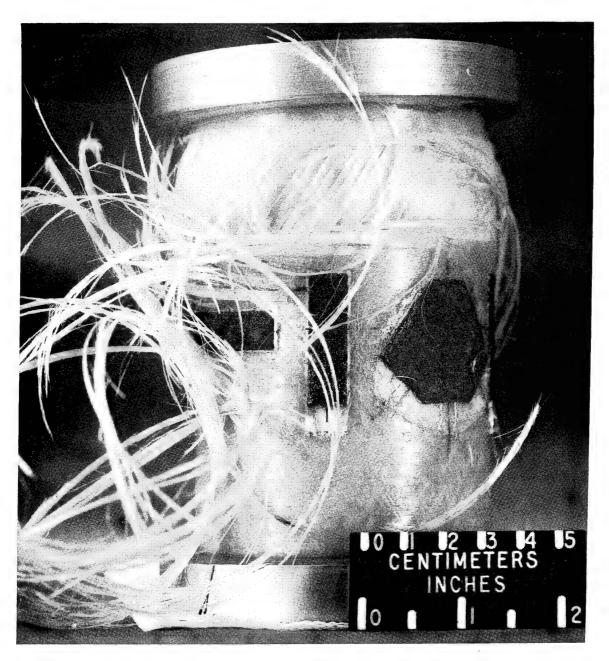
L-66-10069

occurred in a similar though more gradual manner. All the cylinders were porous to the extent that a bladder of some sort was required to seal against seepage leaks during pressurization. This problem was particularly acute for the orthotropic glass-epoxy cylinder, and a 1100-0 aluminum-alloy sheet liner (shown in fig. 23) was necessary before the cylinder could be effectively pressurized. The increment of pressure calculated to be carried by this aluminum liner at the cylinder failure strength was deducted from the orthotropic glass-epoxy cylinder failure pressure. Composite internal pressure failure strengths were 91.6 and 93.8 ksi (632 and 647 MN/m²), respectively, for the two orthotropic boron-epoxy cylinders and 50.1 ksi (345 MN/m²) for the isotropic boron-epoxy cylinder (table VIII). Comparable strengths for similar glass-epoxy cylinders were 115.0 and 68.9 ksi (793 and 475 MN/m²). The experimental load-strain data were reduced to composite strengths by the following equation:

Figure 24.- Isotropic glass-epoxy cylinder failed by internal pressurization.

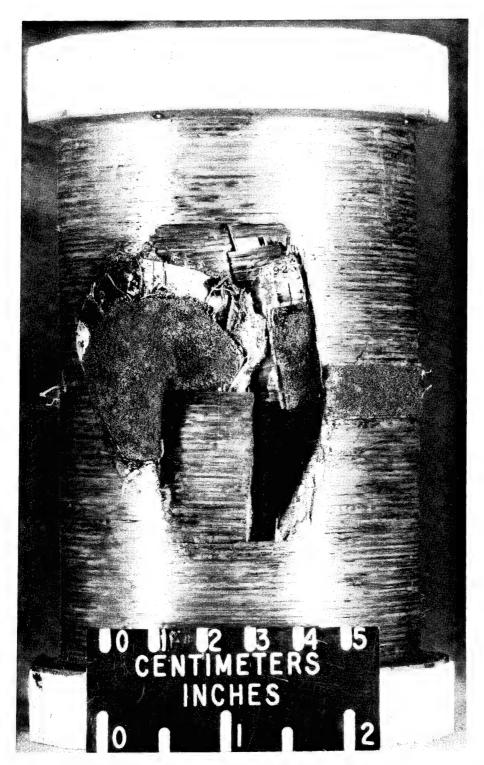
L-67-1518

External pressure failures.— The cylinders shown in figures 25 to 28 were failed by external pressurization. An orthotropic boron-epoxy cylinder is shown in figure 25 with a large hole in its side. The isotropic boron-epoxy cylinder in figure 26 contains three cracks with a common intersection. The orthotropic glass-epoxy cylinder in figure 27 appears to have undergone buckling failure. The surface is covered with minute craze

Experimental external pressure failure strengths for orthotropic and isotropic boron-epoxy cylinders were 25.1 and 13.6 ksi (173 and 93.8 MN/m^2), respectively (table VIII). Comparable strengths for similar glass-epoxy cylinders were 19.4 and 11.5 ksi (134 and 79.3 MN/m^2). The experimental load-strain data were reduced to composite strengths by equation (1); however, for external pressure loading the radius was taken to be the outside cylinder radius. Comparison of these experimental values with those calculated by the various methods listed in table VIII indicated that only those values obtained by the shell buckling method showed reasonable agreement with the experimental values.

Figure 25.- Orthotropic boron-epoxy cylinder failed by external pressurization.

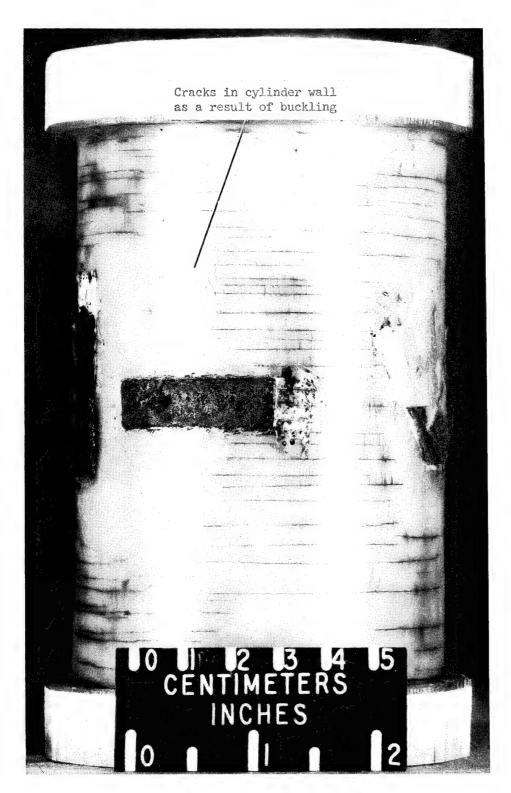
L-67-1519.1

cracks, none of which were present on the surface of the cylinder before testing. The cracks exist in two separate patterns. The circumferential cracks, which are about 0.25 inch (6 mm) apart, are believed to be a consequence of axisymmetric prebuckling deformations which assume a shape similar to that of a transversely corrugated cylinder. The finer, more closely spaced oval arrays of cracks, lengthwise in the center of the cylinder and circumferentially about 120° apart, are evidence of a diamond-shaped buckle pattern. Failure occurred abruptly for all cylinders. Latex or chlorobutyl rubber external coatings were used to seal against slow fluid leaks through the porous cylinder walls. The failure area in the isotropic glass-epoxy cylinder (fig. 28) resembles a bruise on a piece of fruit. The black circumferential line segments in the failure area are pockets of the chlorobutyl rubber coating which was applied externally before testing and not completely removed before this photograph was taken.

Figure 27.- Orthotropic glass-epoxy cylinder failed by external pressurization.

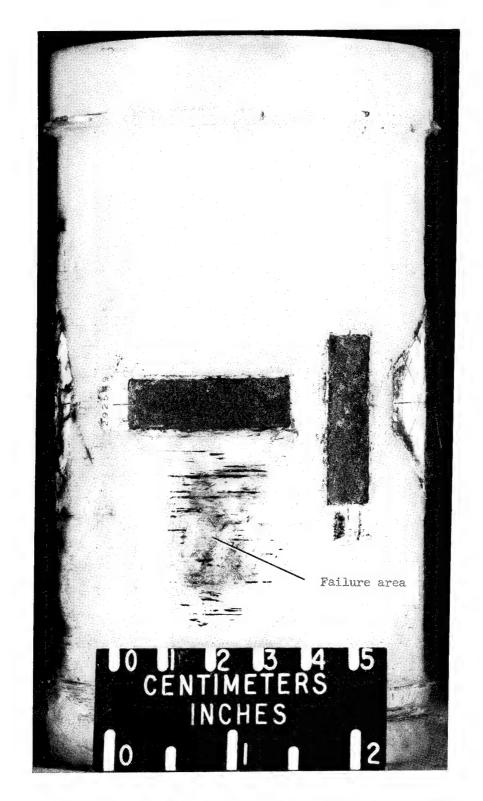
L-67-1521.1

Figure 28.- Isotropic glass-epoxy cylinder failed by external pressurization.

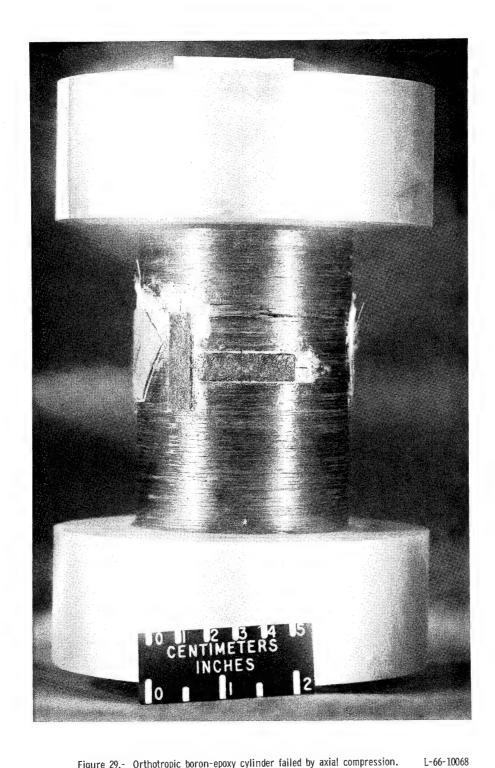
Axial compression failures. The cylinders failed by axial compression are shown in figures 29 to 32. The orthotropic boron-epoxy cylinder is shown in figure 29 with failure evidenced externally by a circumferential split in the cylinder wall. The isotropic boron-epoxy cylinder in figure 30 failed around the full circumference near the bottom of the cylinder. The orthotropic glass-epoxy cylinder (fig. 31) also failed around the full circumference near the bottom. Some evidence of prebuckling deformations occurs in the form of circumferential cracks in the wall of the orthotropic glass-epoxy cylinder (fig. 31). These cracks are similar to those seen on the surface of the orthotropic glass-epoxy cylinder failed by external pressurization (fig. 28) except that here no evidence of buckling exists. Cracks were not evident on the surface of the specimen prior to testing. The failure of the isotropic glass-epoxy cylinder (fig. 32) appears similar to that exhibited by the orthotropic boron-epoxy specimen (fig. 29) with a circumferential split in the wall.

Figure 29.- Orthotropic boron-epoxy cylinder failed by axial compression.

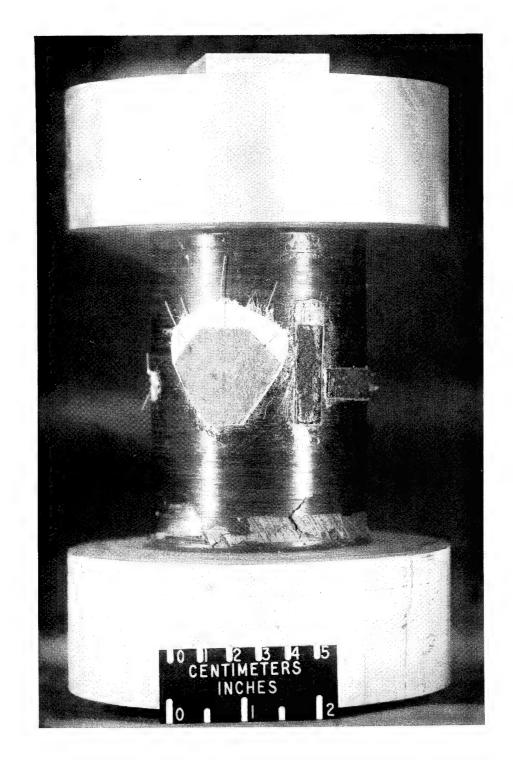
L-66-10066

Figure 30.- Isotropic boron-epoxy cylinder failed by axial compression.

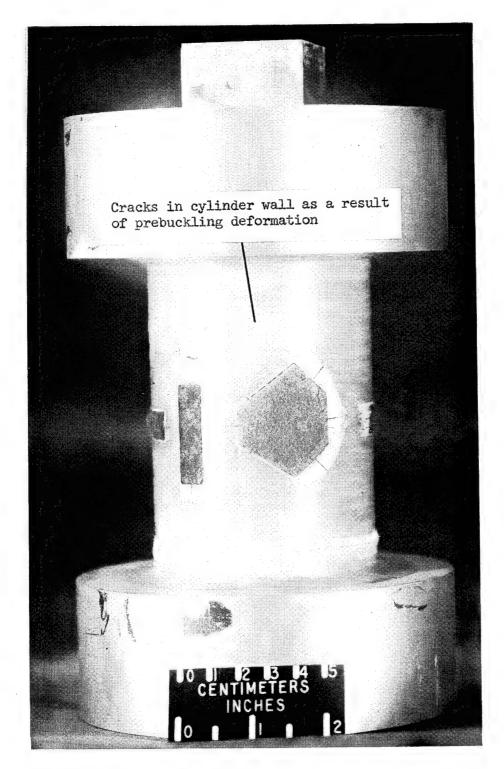
L-66-10067.1

Figure 31.- Orthotropic glass-epoxy cylinder failed by axial compression.

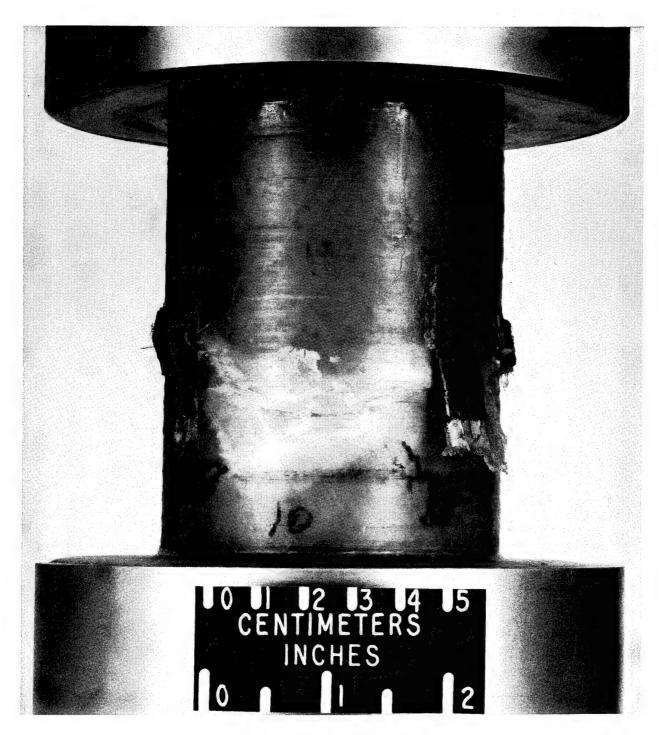
Figure 32.- Isotropic glass-epoxy cylinder failed by axial compression.
